What's Coming out of Tile Drains? Year 2 Outcomes

This report is part of the Sustainable Food and Fibre
Futures Fund Project SFFF 19079

December 2023

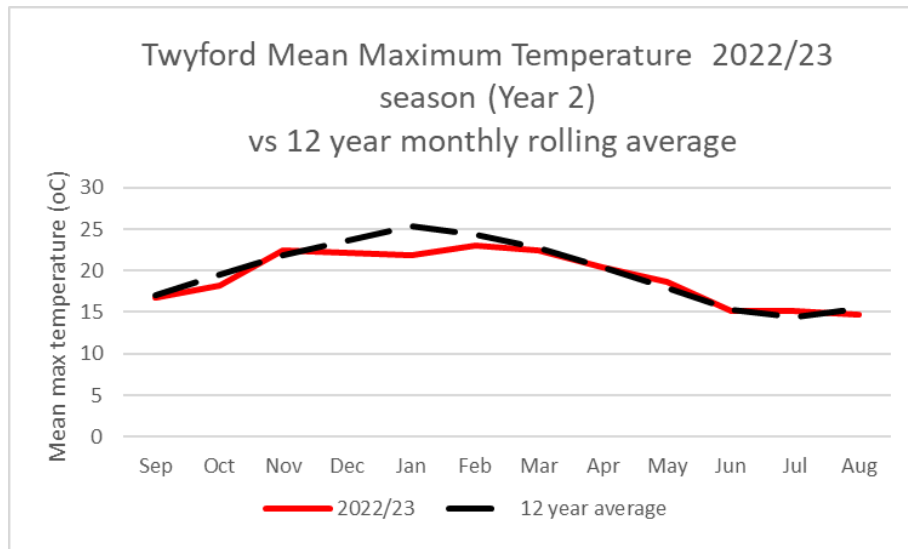
Figure 3 Mean maximum temperature data for Year 2 for the Hortwatch Twyford weather station for the 2022/23 season, compared to the 12 year rolling average.

The mean maximum temperature was close to the 12 year average except over the summer months, when it was lower. The mean minimum temperature tended to be slightly above the 12 year average except in March, July and August where it was slightly lower.

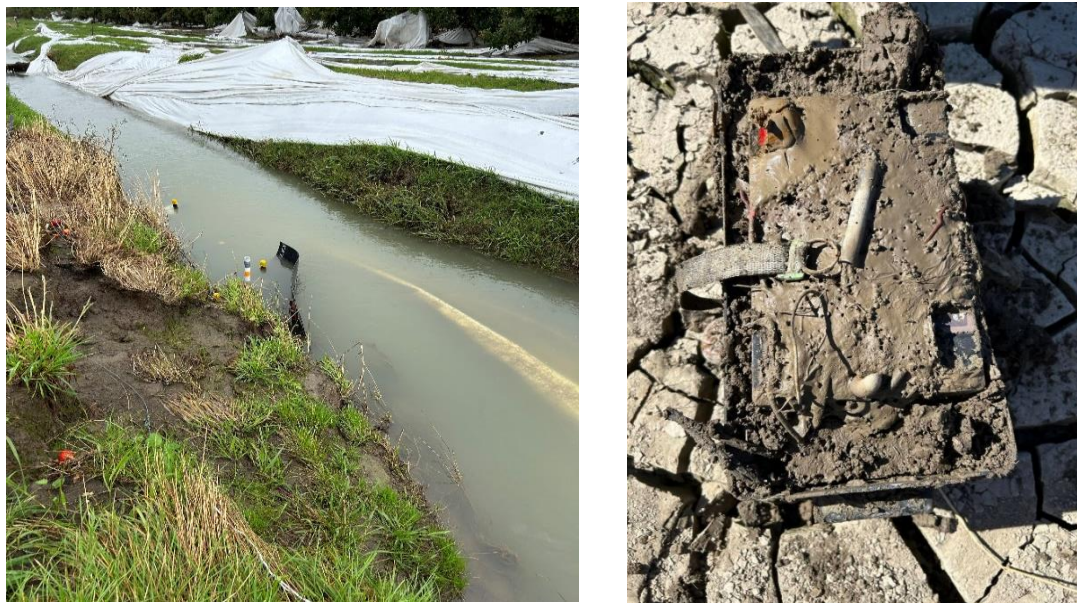
Figure 5 (a,b), cyclone impacts to monitoring equipment

Massey University assisted with the repairs and maintenance on all proportional sampling and flow metering equipment following the cyclone, with all sites except A05 fully reinstated and monitoring by June. Repairs included flushing all equipment of silt, realigning pipework within the drains, and some rewiring of flow meter controllers where these were inundated with floodwater.

This site was the most significantly impacted by Cyclone Gabrielle. Electronic equipment at this site was damaged beyond repair, and site access following the cyclone and for the remainder of Year 2 was hazardous due to the extensive silt deposits across the orchard, on the tracks and along the drain edge. The orchard itself has now been pulled out, with replanting to occur.

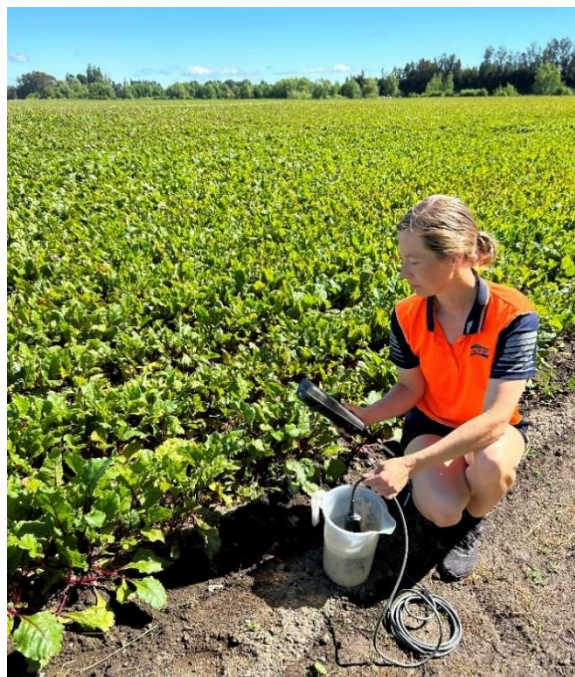
Figure 6 Field data collection from tile drain discharge sample from a cropping paddock

The ProQuatro handheld meter was used to record the temperature, pH, dissolved oxygen, and conductivity of each water grab sample collected. The meter is pH calibrated on a regular schedule by our sampling technicians, and gets sent away annually for a full calibration of all functions.

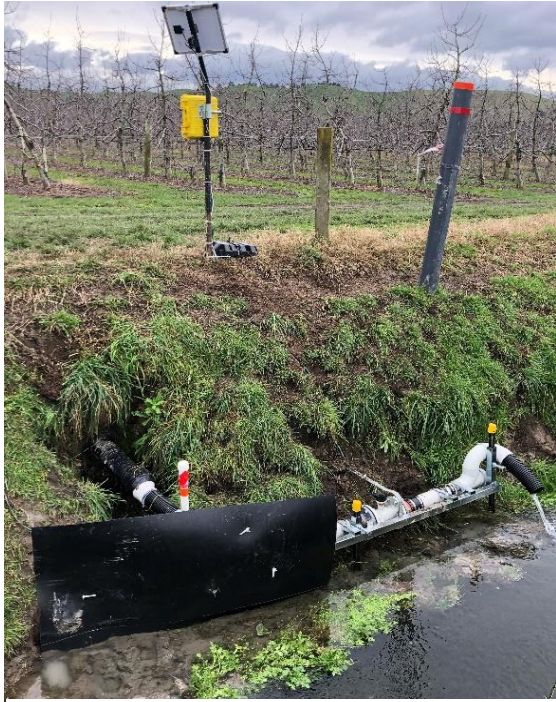
Figure 8 In Drain Proportional Sampling and Flow Metering equipment

The In Drain design sits on the drain edge and attaches to the tile exit end. The water passes from the tile exit, through the proportional sampler and flow meter, before discharging into the receiving water body drain. This design means that the sampling equipment footprint is in the drain itself, and not impeding on grower activity and use of the headland. This however, required coordination with Hawke's Bay Regional Council and their drainage network maintenance team.

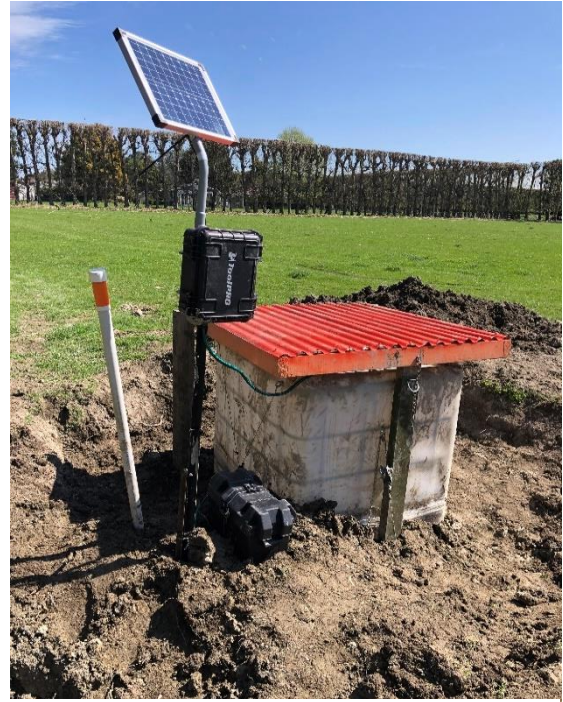
Figure 7 Pod Proportional Sampling and Flow metering equipment

The Pod design is a shell dug into the ground overtop of the tile, housing the flow meter and proportional sampling collection container inside. The water then runs from the tile, through the proportional sampler and flow meter, then passes back into the tile line.

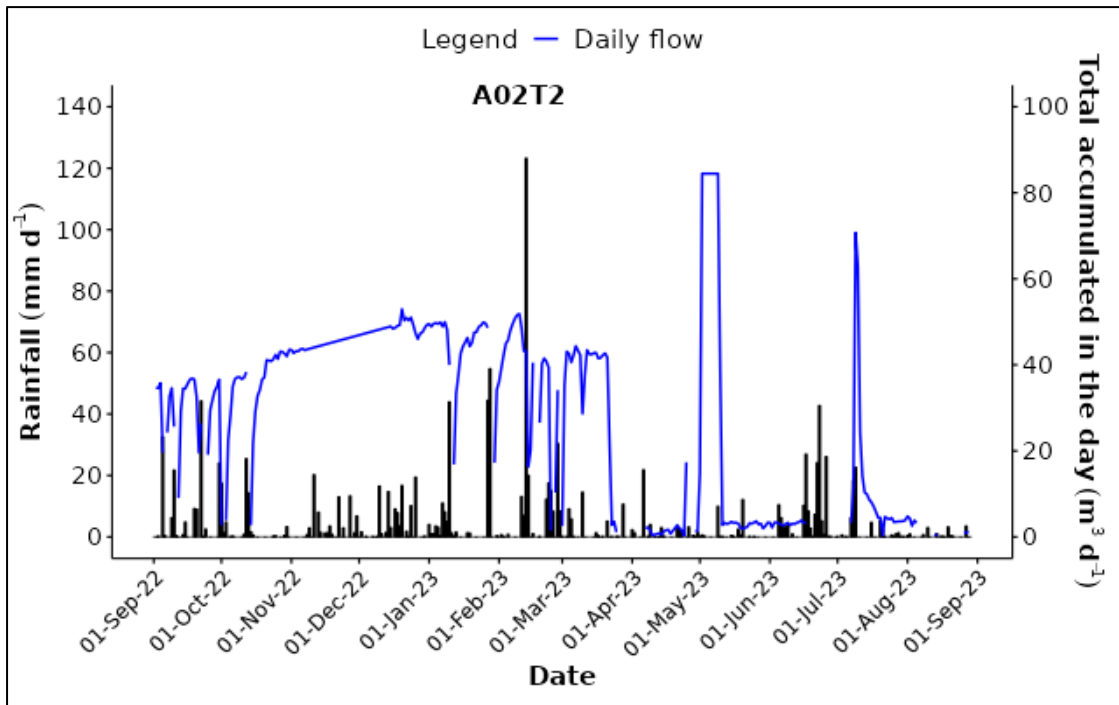
Figure 12 A02T2 Flow data vs rainfall

There is an issue with the A02T2 data, where the flow meter was wired incorrectly until 6th July 2023, and consequently, this data is inverted on the flow graph output. Massey is currently working on resolving this data issue.

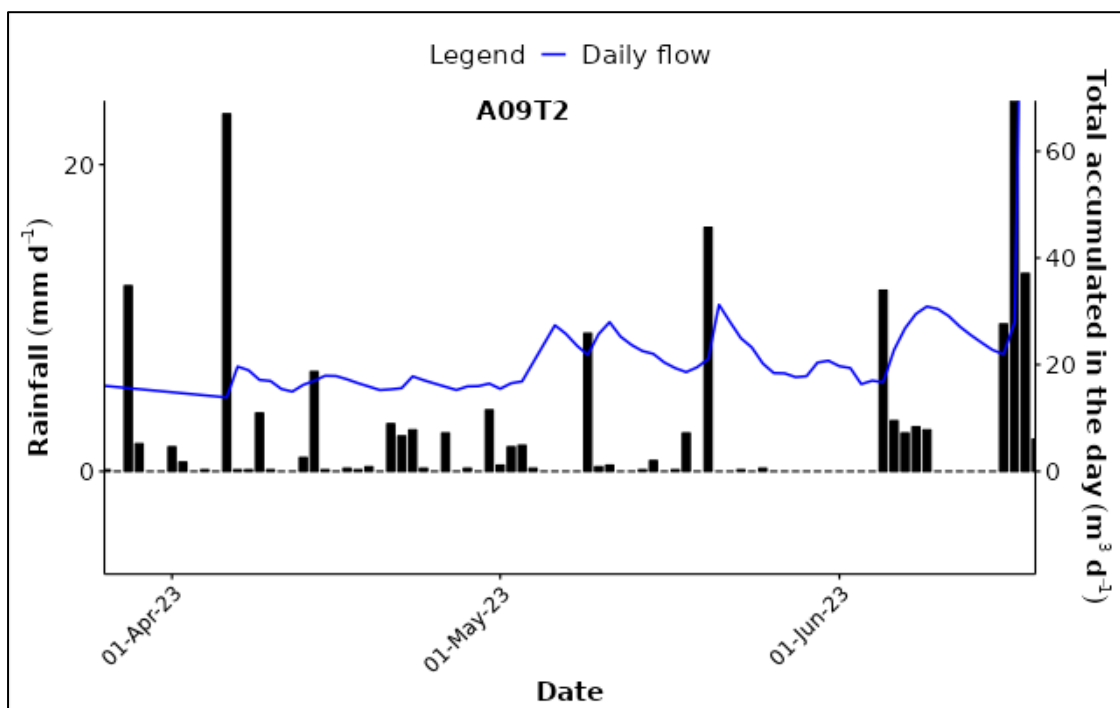
Figure 19 A09T2 Flow data vs Rainfall - shows that even the "low flow" periods at this tile have a significant accumulated flow in the day

Tile 2 shows much higher accumulated flows, up to 480m³ per day. Included is a zoomed in graph, showing that for this tile, even periods of lower flow are accumulating 20-30 m³ per day.

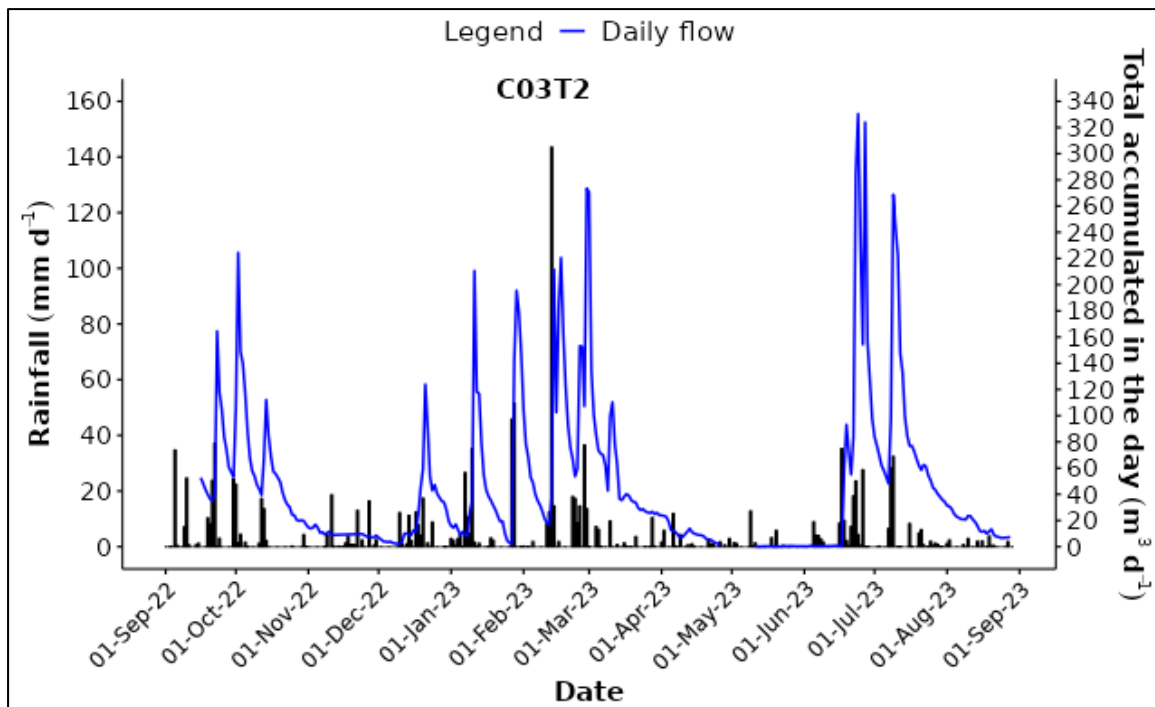
Figure 23 C03T2 Flow data vs Rainfall

Both tiles had been classified as having event flow. Tile 2 shows frequent flow following rainfall, with a long falling limb time back to base flow. Tile 1 does not reach as high a peak as Tile 2, nor is the flow as regular following rainfall. There is a potential flow outlier in December, where the highest peak was recorded despite a reduced amount of rainfall, higher than the highest rainfall experienced during the cyclone.

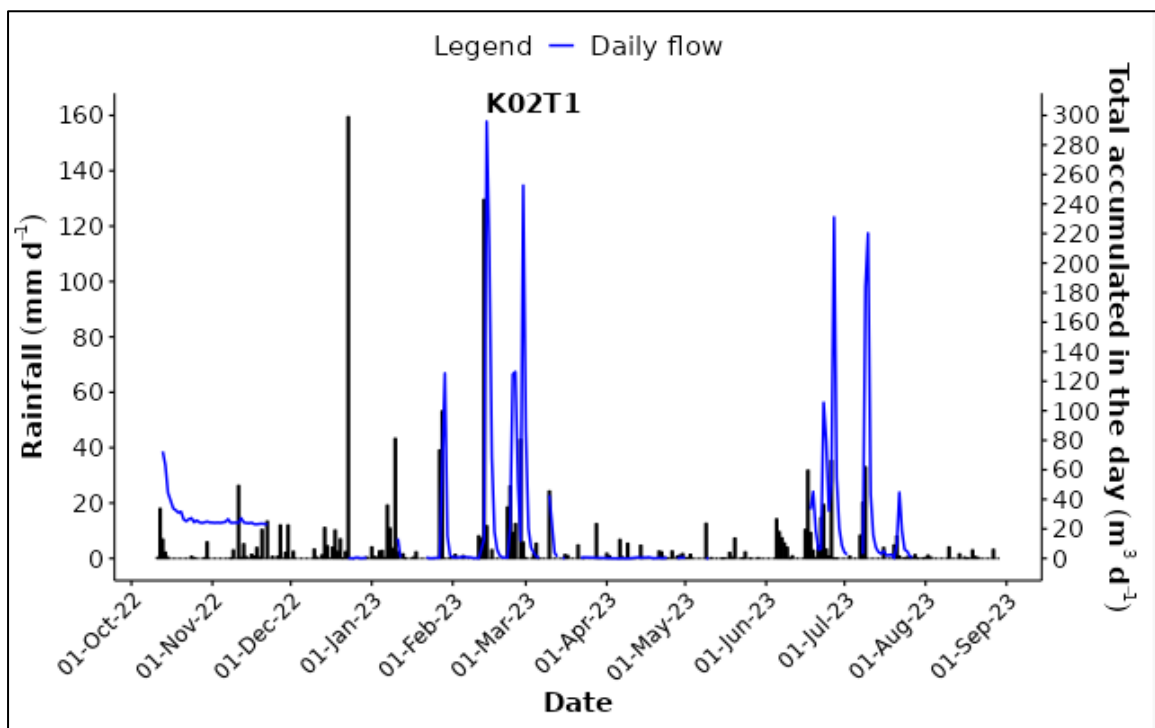
Figure 24 K02T1 Flow data vs Rainfall

This site shows short flow lag times, with peaks happening immediately following rainfall events, and the falling limb times happening straight away back to base flow. This site was characterised as having event flow, and the flow meter data suggests the same.

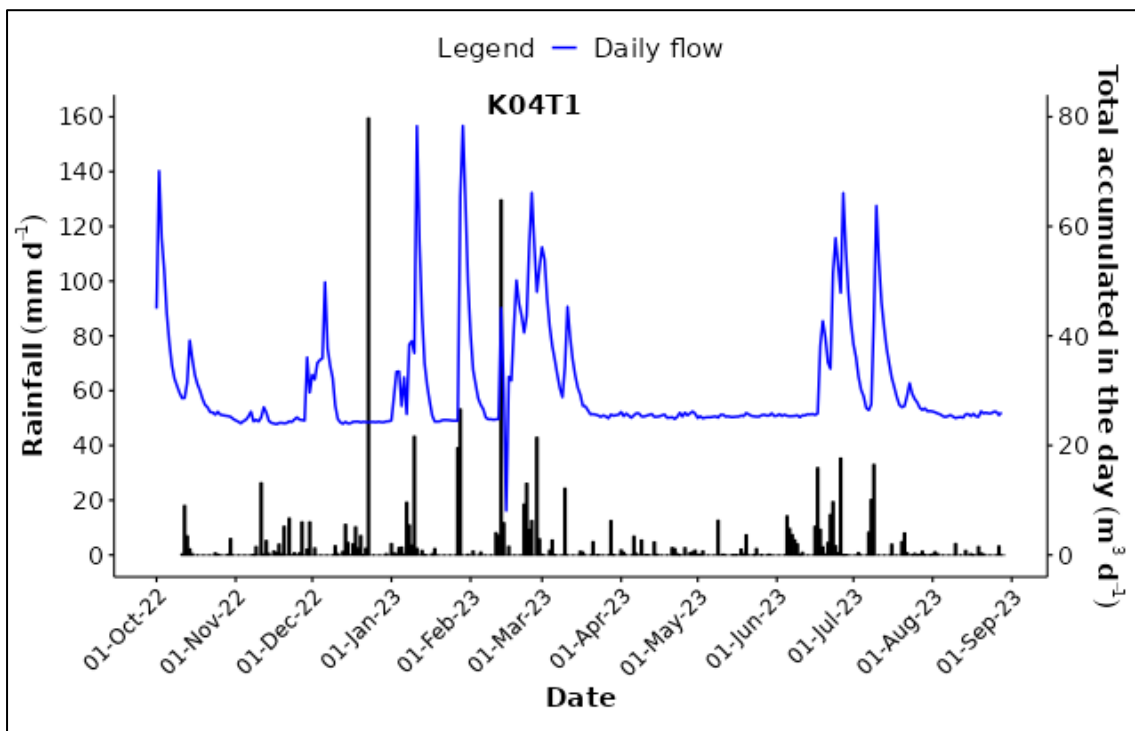
Figure 26 K04T1 Flow data vs Rainfall

The flow meter graph output for each of these tiles needs correcting, as the flow meters zero point was set too high. However, the flow profile shows the event flow behaviour category to be accurate, and the falling limb to base flow to take a longer period than some of the other tiles.

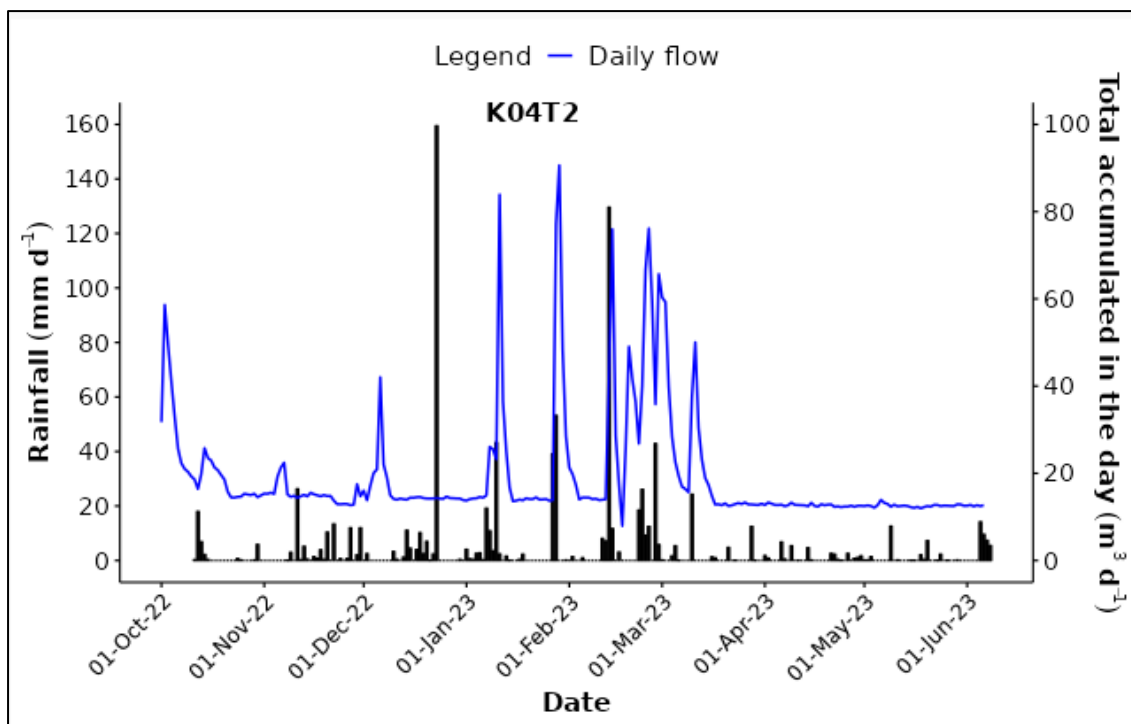
Figure 27 K04T2 Flow data vs Rainfall
